<b>Subject:</b>  <b>BLOWER MOTOR STAYS ON AFTER KEY OFF</b>	<b>Bulletin No:</b> 07-003/11
	<b>Last Issued:</b> 05/26/2011

2007-2010 CX-9 built before JM3 TB\*\*\*\* A\* 227576 (May 17, 2010)

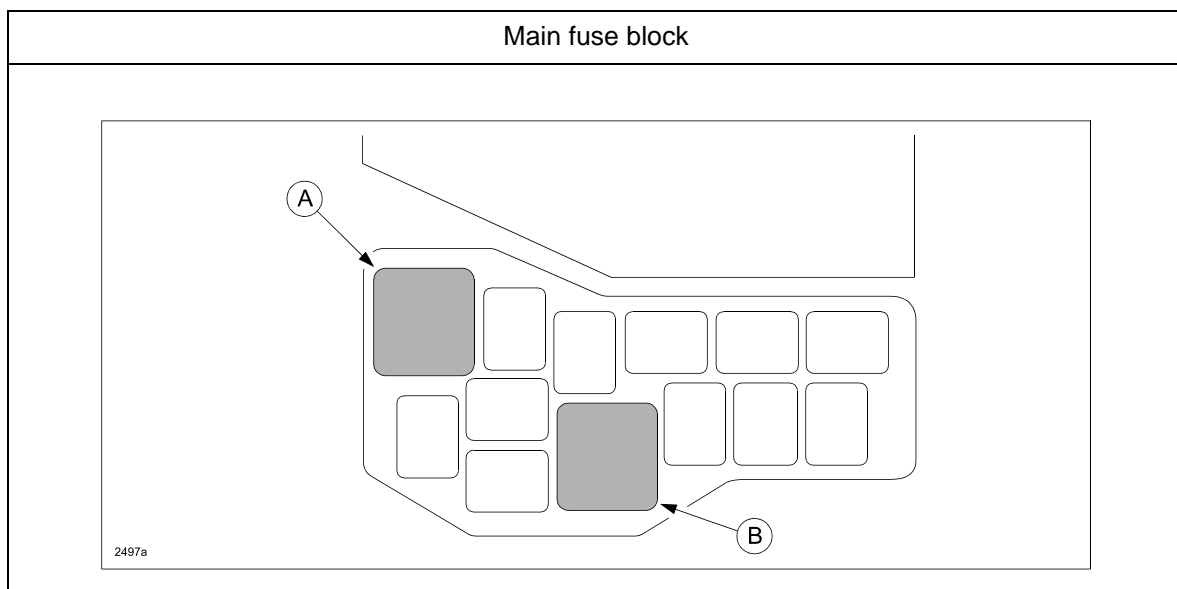
Some vehicles may experience the front or rear blower motor staying on intermittently after ignition key is switched to the off position. The condition may be difficult to duplicate. This may be caused by a faulty front and/or rear blower motor relay. A new and improved blower motor relay has been developed to correct this concern.

If customer complains about an intermittent front or rear blower motor operation after ignition key is switched to the off position, replace both front (A) and rear (B) blower motor relays.
